Manhole Inspection Summary

Manhole # S35A__029MH

Insp Date: **11/14/08 10:13 AM**

Location Address: **508 st paul st**

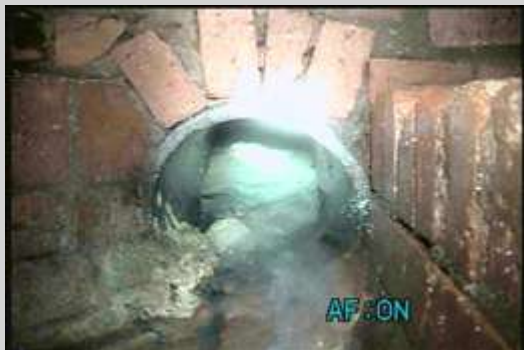
12 O'Clock Outflow

8 in. Circular Gravity Sewer
Pipe Out @ 12 O'Clock

Pipe Material: **Clay** ☐ Pipe Lined

Invert Depth: 11.25 (ft.) Flow Characteristics: **Fast**

Deposits: ☒ None ☐ Mud ☐ Sludge ☐ Debris ☐ Grease

Infiltration: **None** Pipe Seal Cond: **Unknown**

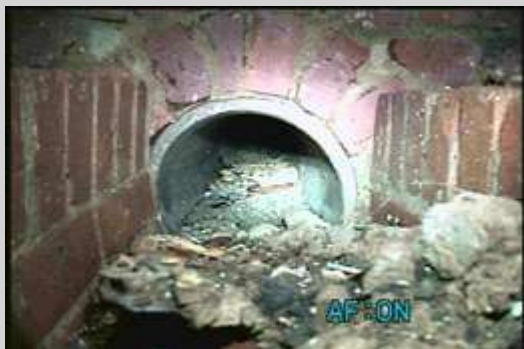
6 O'Clock Inflow

8 in. Circular Gravity Sewer
Pipe In @ 6 O'Clock

Pipe Material: **Clay** ☐ Pipe Lined

Invert Depth: 10.92 (ft.) Flow Characteristics: **None**

Deposits: ☒ None ☐ Mud ☐ Sludge ☐ Debris ☐ Grease

Infiltration: **None** Pipe Seal Cond: **Unknown**

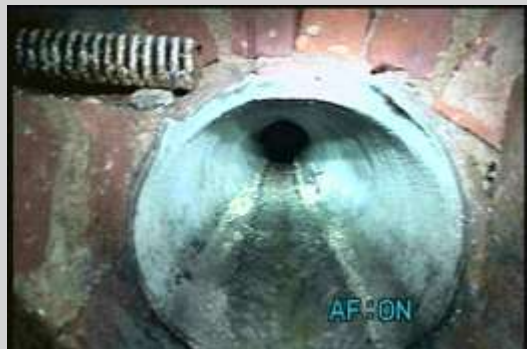
9 O'Clock Inflow

8 in. Circular Gravity Sewer
Pipe In @ 9 O'Clock

Pipe Material: **Clay** ☐ Pipe Lined

Infiltration: **None** Pipe Seal Cond: **Unknown**
